Contract #: 04-0120F4Cty: SF/ALA Rte: 80 PM: 13.2/13.9File #: 69.28**WELDING INSPECTION REPORT****Resident Engineer:**Siegenthaler, Peter**Address:** 333 Burma Road**City:** Oakland, CA 94607**Report No:** WIR-024349**Date Inspected:** 08-Jun-2011**Project Name:** SAS Superstructure**OSM Arrival Time:** 700**Prime Contractor:** American Bridge/Fluor Enterprises, a JV**OSM Departure Time:** 1900**Contractor:** Zhenhua Port Machinery Company, Ltd (ZPMC), Changxing Island **Location:** Shanghai, China**CWI Name:** Lu Hua Jie**CWI Present:** Yes No**Inspected CWI report:** Yes No N/A**Rod Oven in Use:** Yes No N/A**Electrode to specification:** Yes No N/A**Weld Procedures Followed:** Yes No N/A**Qualified Welders:** Yes No N/A**Verified Joint Fit-up:** Yes No N/A**Approved Drawings:** Yes No N/A**Approved WPS:** Yes No N/A**Delayed / Cancelled:** Yes No N/A**Bridge No:** 34-0006**Component:** OBG**Summary of Items Observed:**

TRIAL ASSEMBLY YARD

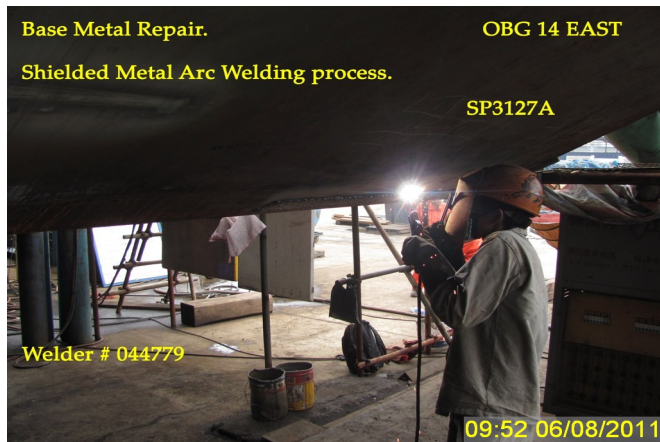
This QA Inspector observed ZPMC qualified welding personnel identified as 044779 Perform Shielded Metal Arc Welding (SMAW) on OBG Segment 14 East side panel between PP128.3 and PP128.7 (Bike path side). VT repair on some locations. ZPMC QC Identified as Zhu Yuan Gang with Critical welding repair report CWR-B-CWR2944. The welding parameters as measured using QC's calibrated instrument appeared to be in general compliance with WPS-345-SMAW-4G (4F) FCM-Repair-1.
